**WARMINGTON STREET PADDINGTON FIRE
4 SEPTEMBER 2016**

OPERATIONAL REVIEW

RELEASE DATE: 28 OCTOBER 2016

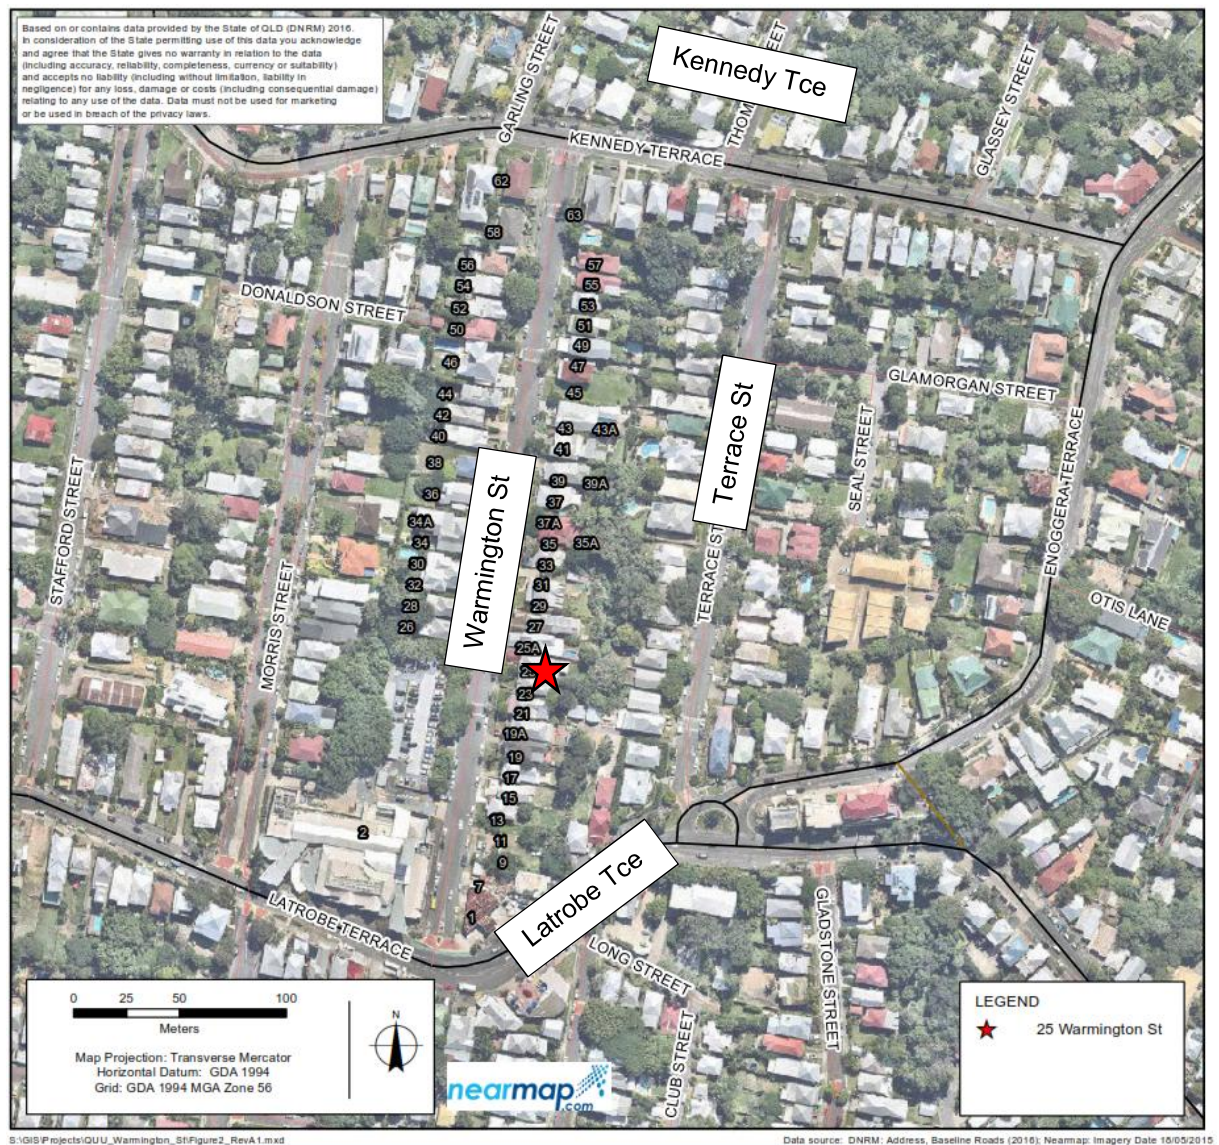
Figure 2 Site plan

The locality of the subject site is shown in Figure 1 with additional detail in Figure 2. Warmington Street is mostly residential with a shopping centre ("Paddington Central") located at the junction of Warmington Street and Latrobe Terrace. From the subject property at 25 Warmington Street, the street rises gradually to Latrobe Terrace to the south, and falls gradually to the north to a low point before rising to Kennedy Terrace. The elevation of the street outside the subject property is approximately 32m above the Australian Height Datum (AHD). The subject property rises slightly from the street. The houses at 25 and 25A Warmington Street were two-storey timber dwellings.

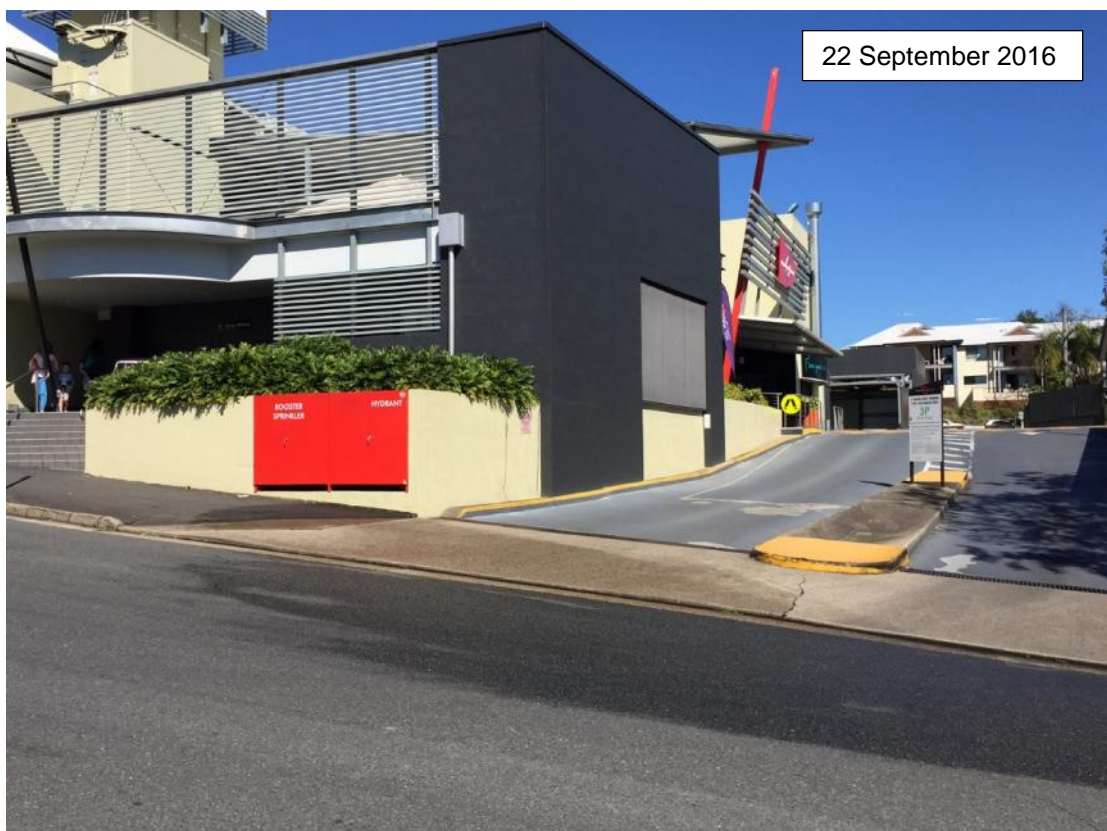
Figure 5 Fire booster assembly (H-1) at Paddington Central Shopping Centre

At the Paddington Central Shopping Centre, there is a fire booster assembly (Private Hydrant H-1) located adjacent to the car park entry (refer Figure 5). According to the records provided, H-1 was the first alternative hydrant accessed after supply from H-2 was deployed. H-1 is not owned or maintained by QUU and, as such, it is not subject to the DEWS Guidelines (refer Chapter 6, Section 6.6.1).

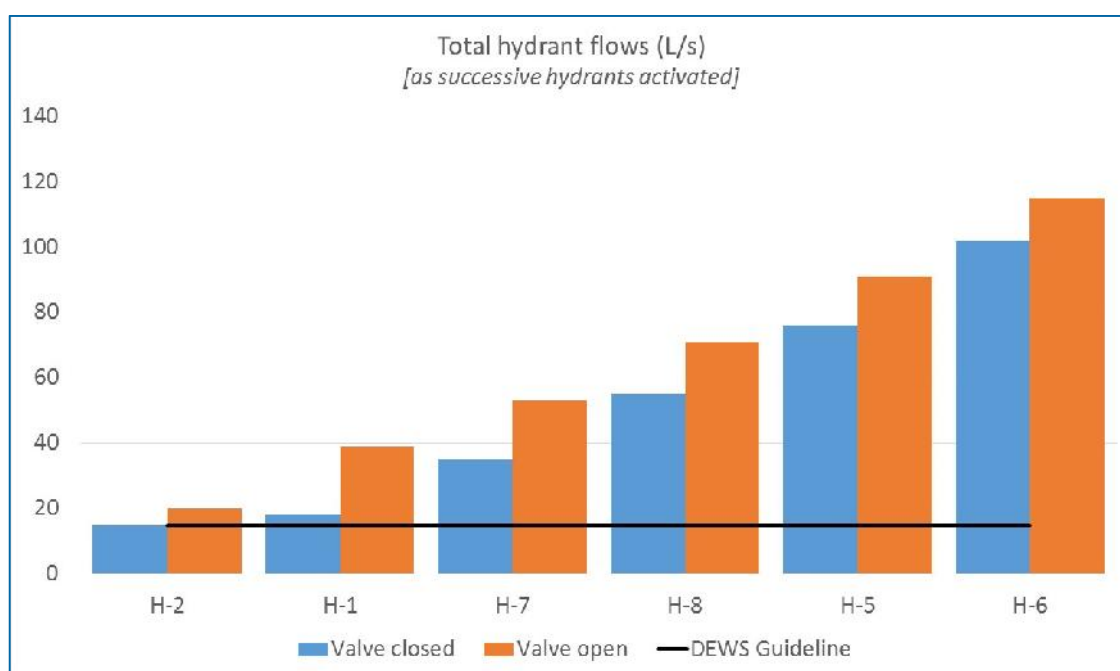
Figure 6 Cumulative available flow

Table 4 Available flow assessment (valve open)

Location	Case 1 Flow (L/s) Head (m)	Case 2 Flow (L/s) Head (m)	Case 3 Flow (L/s) Head (m)	Case 4 Flow (L/s) Head (m)	Case 5 Flow (L/s) Head (m)	Case 6 Flow (L/s) Head (m)
H-2	25 Warrington St	20 37	15 21	15 20	15 20	15 20	15 19
H-1	Paddington Central (private hydrant)		24 19	23 18	23 18	23 17	23 17
H-7	84 Latrobe Tce			15 41	15 39	15 39	15 38
H-8	76 Alma St				18 39	18 39	18 38
H-5	28 Terrace St					20 44	17 33
H-6	42 Terrace St						27 37
	Total flow	20	39	53	71	91	115
