Wynnum STP Manufacturers Data Report and O&M

1515-000002-QUU Wynnum STP RO and UF Membrane Replacement

QUU WYNNUM MEMBRANE REPLACEMENT REPORT

EVOQUA WATER TECHNOLOGIES
MEMBRANE MODULE AUTOPSY REPORT
15th May 2015

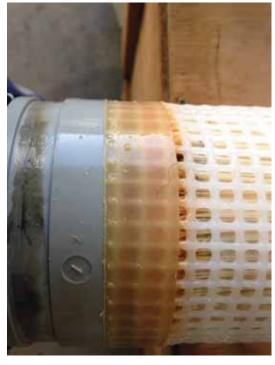
Figure 1 MF Membrane Condition

The MF modules removed were in relatively good condition given their age. A small amount of black substance was visible at the top and bottom of the module. A number of the pots had swelled slightly making removal difficult. A fine sand like grit was apparent around the module housing threads and O-rings. All O-rings showed signs of deterioration due to chloramine exposure.

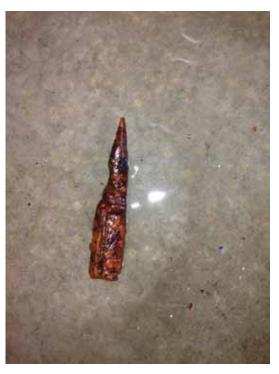
Figure 4 Installation tool found in pressure tube.

The feed spacer of the first membrane for both Stage 1 and Stage 2 was fouled with a large amount of particulate matter, both rust and plastic. A large metal tool bit (potentially a thread tapping bit) was found in the feed spacer of RO2 Vessel 1A. However, due to the large space in the feed cavity there was no indication that the fouling was causing any significant issues.

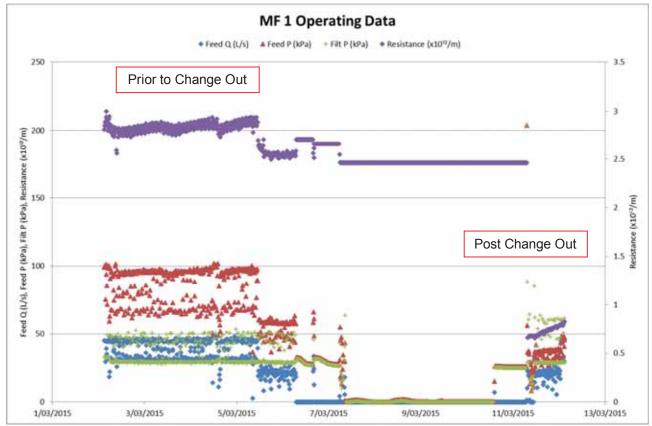
Figure 5: MF 1 Operating Data

In addition the resistance of the units was quite high however once the membranes were replaced the resistance dropped to expected levels. The level of resistance build up was consistent with aged membranes in a waste water treatment plant.

Figure 5 and Figure 6 show the MF operation before and after membrane change out. It can be seen that Resistance dropped from the high levels seen prior to change out.

The PDT results for the MF plant indicated a loss of membrane integrity. Historical progression of PDT data was not available during membrane replacement. As the membranes ages individual fibres can become damaged. Integrity can be restored by undertaking pinning of the membrane module. It is important that regular maintenance including pinning of the MF system is undertaken. EWT are able to offer scheduled or occasional MF maintenance under a service agreement.

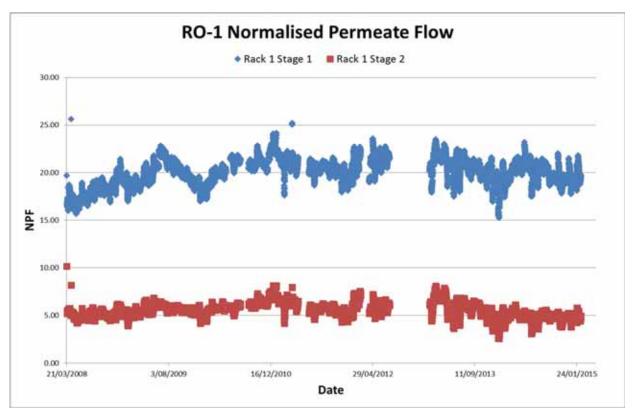
Figure 7: RO-1 Normalised Permeate Flow

The RO System operating data was examined. The normalised permeate flow was relatively stable for the majority of the operating life of the plant. The normalised permeate flow gives an indication of membrane fouling and the resistance to flow. It was noted that data received for the two RO racks was very similar.

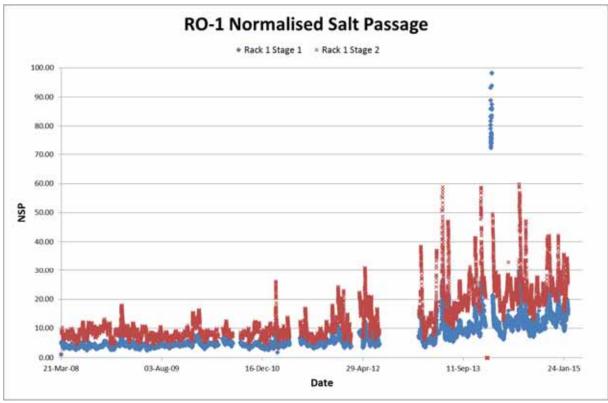
Figure 9: RO-1 Normalised Salt Passage

The normalised salt passage was also examined. The normalised salt passage can be seen to increase slowly over time. There rate of salt passage increased towards the end of the membrane life, however this is not abnormal based on aging of the membrane.

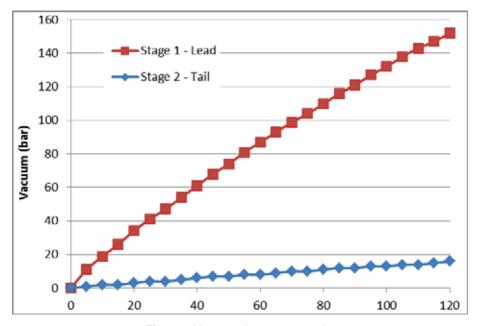
Figure 3 Vacuum decay test results.

The vacuum decay test was used to determine the physical integrity of the reverse osmosis elements and the membrane. A vacuum of 700 mbar was applied on the permeate side and the vacuum decay was monitored over time (Figure 3). A decay of more than 100 mbar in the first minute is a sign of physical damage. Both elements passed the test. The vacuum loss in Stage 1 – Lead was 87 mbar after one minute while it was only 8 mbar for Stage 2 – Tail element.

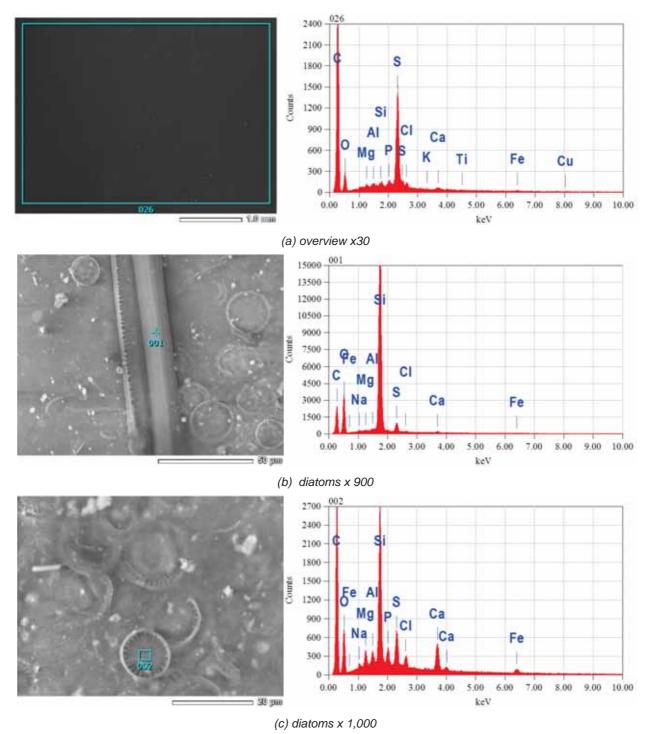
Figure 11 SEM images and EDS analysis of Stage 1 – Lead, lead sample.

The overview image of the lead sample showed that the surface was mainly free of deposits (Figure 11a). The EDS analysis showed significant peaks for the membrane material only. However, high magnification images and EDS analysis showed the presence of diatoms on the surface (Figure 11b-c). Diatoms are unicellular algae enclosed in a silica wall.

rejection. The SEM-EDS analysis showed the presence of diatoms on the membrane. Diatoms have a hard cell wall made of silica that could lead to abrasion of the membrane surface. The increase in salt passage had been gradual over the years so it was not due to a single event. Membrane Futures opinion is that the increase in salt passage was caused by membrane ageing and possibly abrasion caused by the diatoms.

The diatoms were approximately 10 μ m in size and should be removed by ultrafiltration. Membrane Futures recommends reviewing the pre-treatment of the plant. The high pH CIP appeared to have kept biofouling development under control. If possible, cleaning in the reverse direction of the flow is preferable as it prevents pushing the fouling material further in the process.

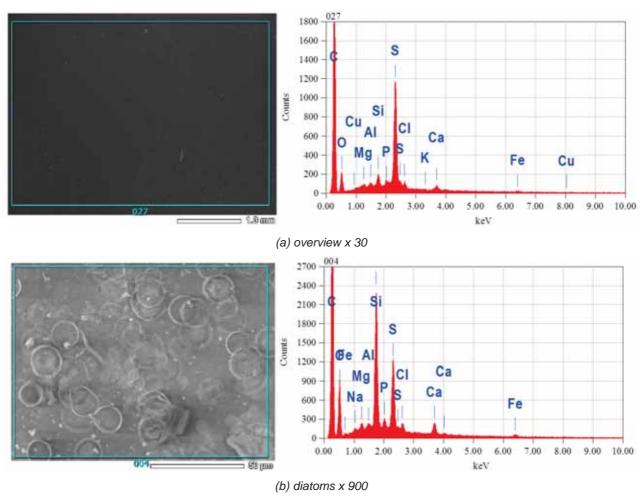
Figure 12 SEM images and EDS analysis of Stage 1 - Lead, tail sample.

The overview image of the tail sample showed that the surface was mainly free of deposits (Figure 12a). The EDS analysis showed significant peaks for the membrane material and a small peak for silica. Similarly to the lead sample, high magnification images and EDS analysis showed the presence of diatoms on the surface (Figure 12b).
